AGENDA  
DESIGN COMMISSION  
Community Room, 3rd Floor  
Arlington Heights Village Hall, 33 S. Arlington Heights Rd.  
Arlington Heights, IL 60005  
September 10, 2024  
6:30 PM

A. DC#24-049(H) - 32 N. Belmont Ave - SF/Teardown

It is recommended that the Design Commission require revisions and re-review the proposed new single-family residence located at 32 N. Belmont Avenue. This recommendation is based on the architectural plans received 10/25/23, material list and samples received 9/29/23, and the following:

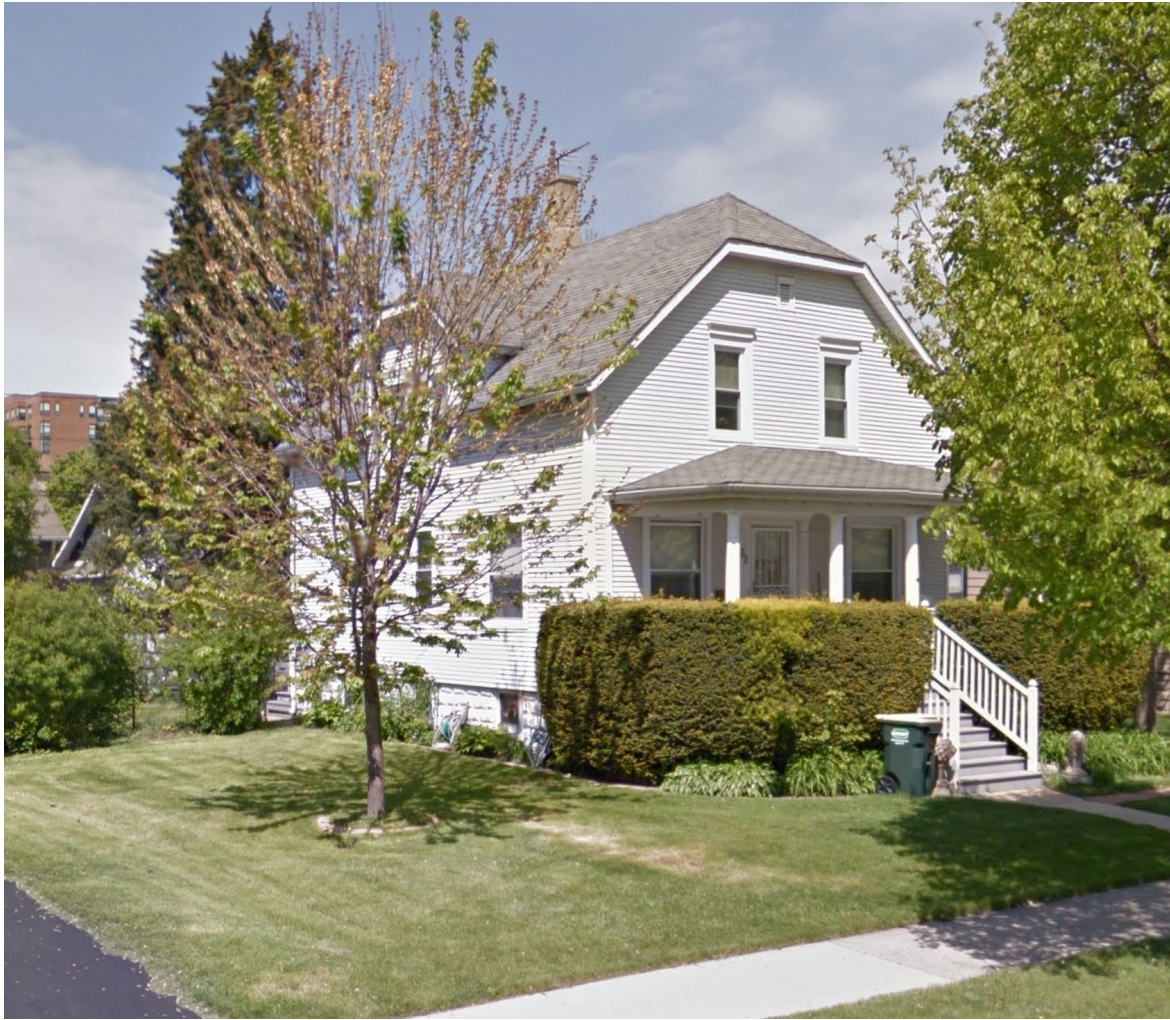
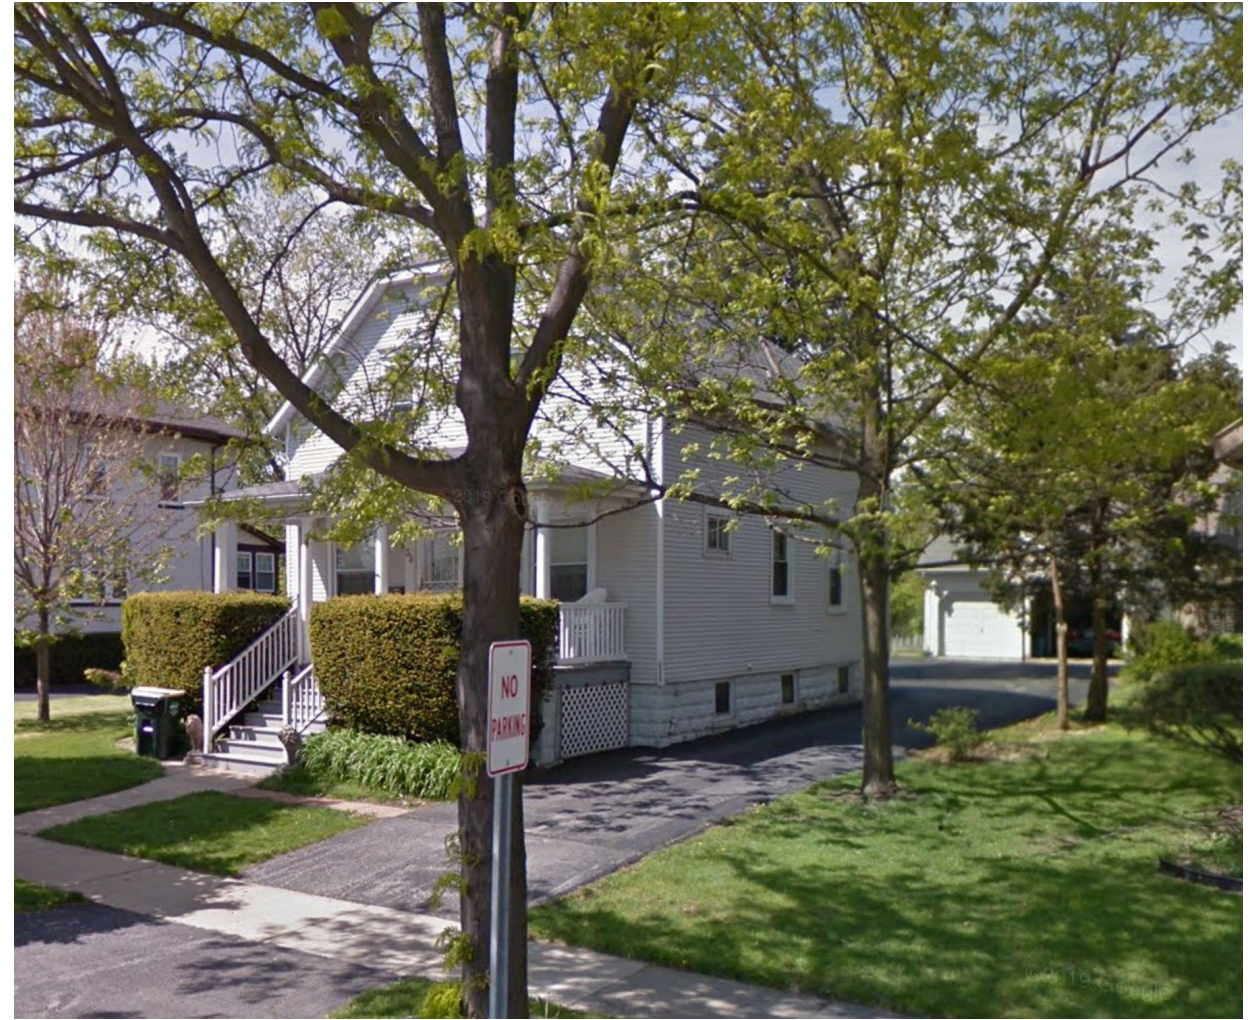
EXISTING HOUSE IN 2012  
IMAGES TAKEN FROM 2012 GOOGLE STREET VIEW

Based on Google Street View images from 2012, the existing house appeared to be in good, well maintained condition. The 2012 images also highlight the home’s historic charm and character as it contributed to the character of the neighborhood. However, based on the inspection report provided by the petitioner, the current condition of the home appears to have been neglected allowing roof damage and water infiltration to damage the home inside and out, requiring extensive repairs.

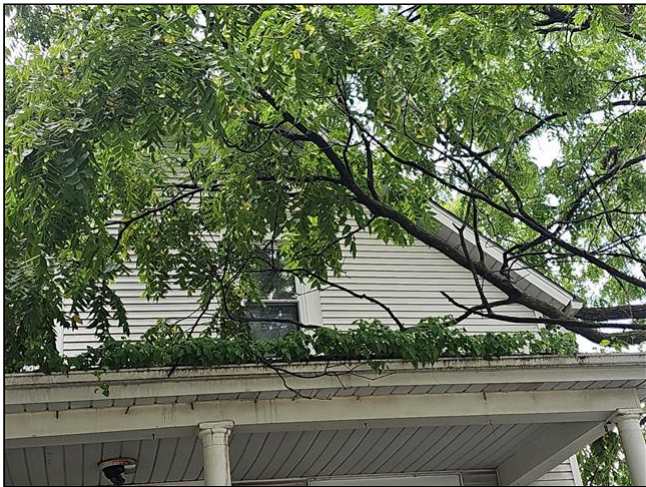
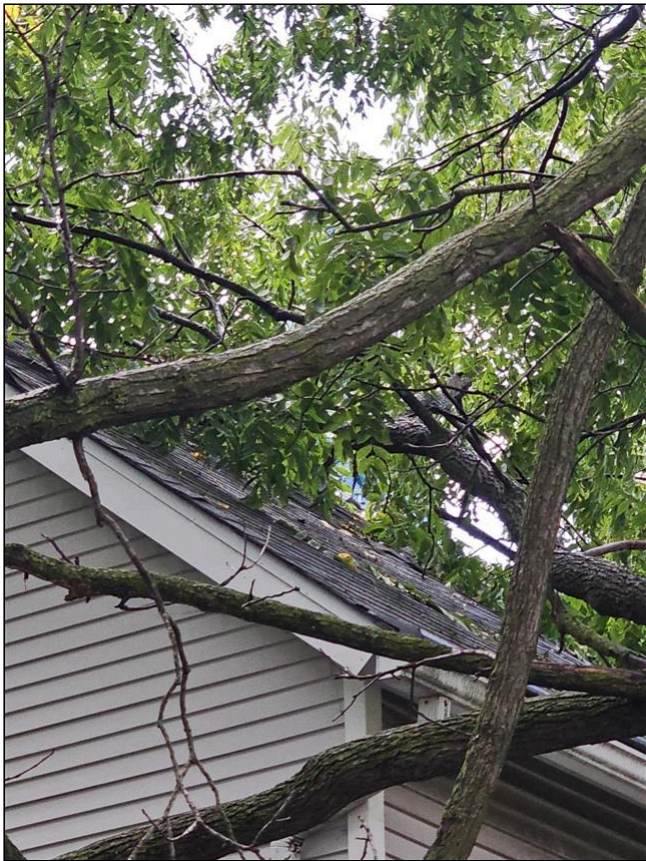
Tree limbs have fallen unto the roof and are in contact with the roof. Damage to roofing and structure has occurred. Roof shingles are also deteriorated and missing. Water is entering the structure. Repairs to the roof structure and replacement of the roofing are needed. Recommend further evaluation by a qualified general contractor and roofing, contractor and repair or replace as needed. Repair / replacement costs will be significant. Item 1(Picture) Item 2(Picture) Item 3(Picture)

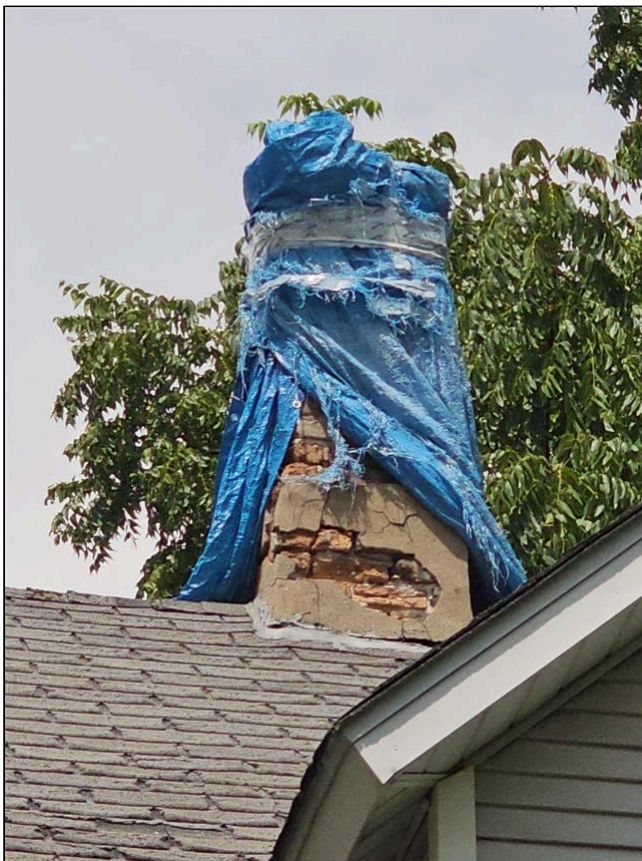
1.1 Item 1(Picture)

- ⚠ The brick chimney is covered with a tarp deteriorated, failing and at risk of collapsing. This is considered unsafe. A general replacement is likely. Chimney repair / replacement costs will be significant. Recommend further evaluation by a qualified, certified chimney sweep contractor and repair or replace as needed. Repair / replacement costs will be significant. Item 1(Picture)

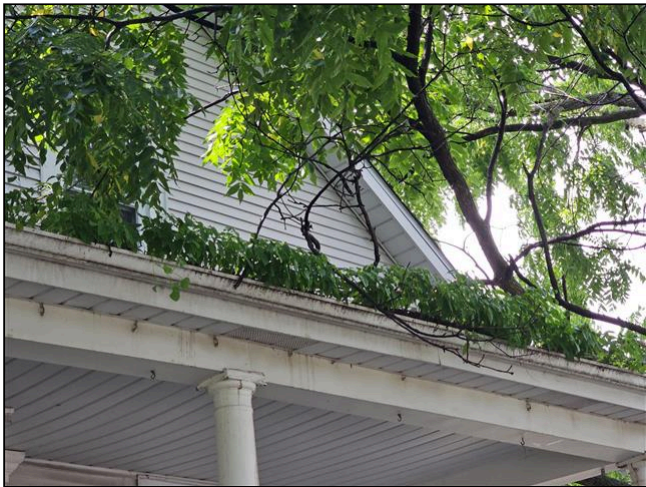
1.2 Item 1(Picture)

- ⚠ The gutters are full of debris and appear damaged and leaking. Downspouts are missing parts and extensions. Because of the amount of damage the wood fascia boards are likely damaged / deteriorated. Recommend further evaluation by a qualified general contractor and repair or replace as needed. Repair

/ replacement costs may be significant. Item 1(Picture) Item 2(Picture) Item 3(Picture)

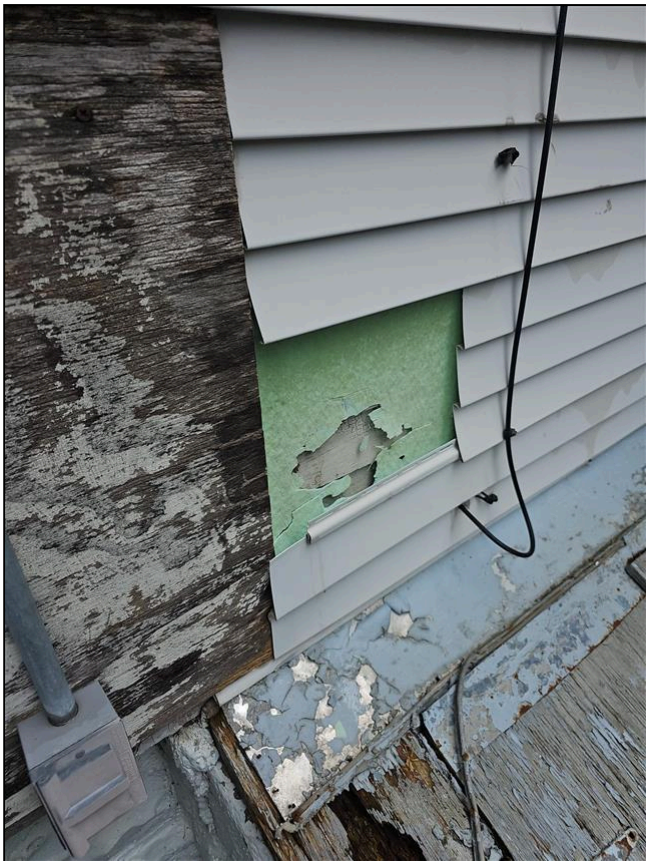
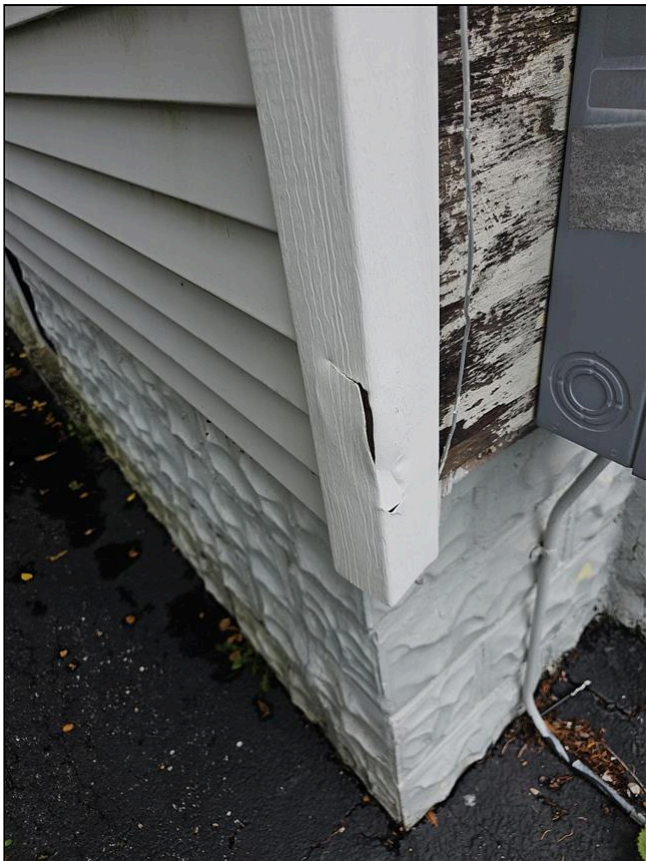
The vinyl siding and accessories at the exterior of home is damaged and missing in areas and appears to be improperly installed directly over /onto the old wood siding. Recommend further evaluation by a qualified general contractor and repair or replace as needed. Repair / replacement costs may be significant. Item 1(Picture) Item 2(Picture) Item 3(Picture)

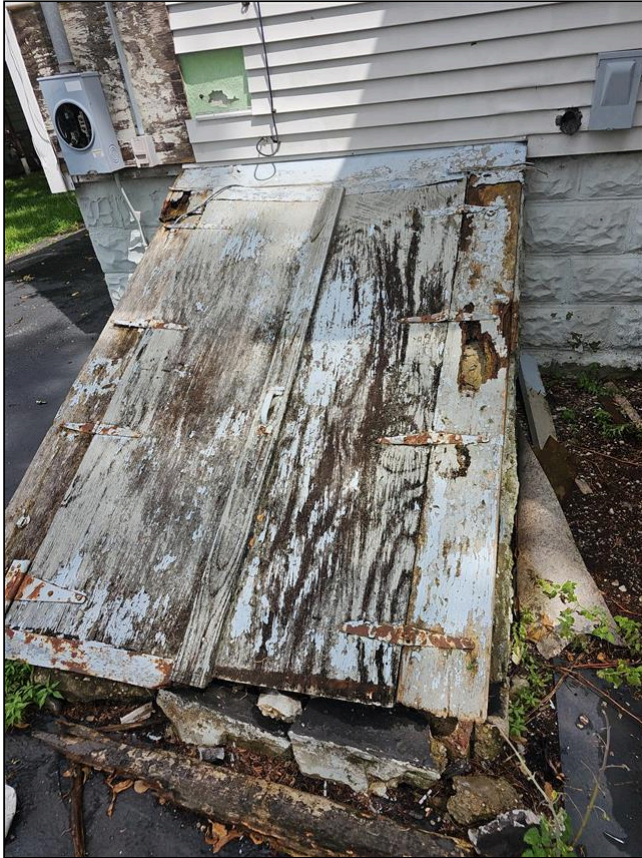
2.1 Item 1(Picture)

(1) The cellar entry doors and frame to the basement at rear of home are deteriorated and unsafe. A general replacement is needed. Item 1(Picture)

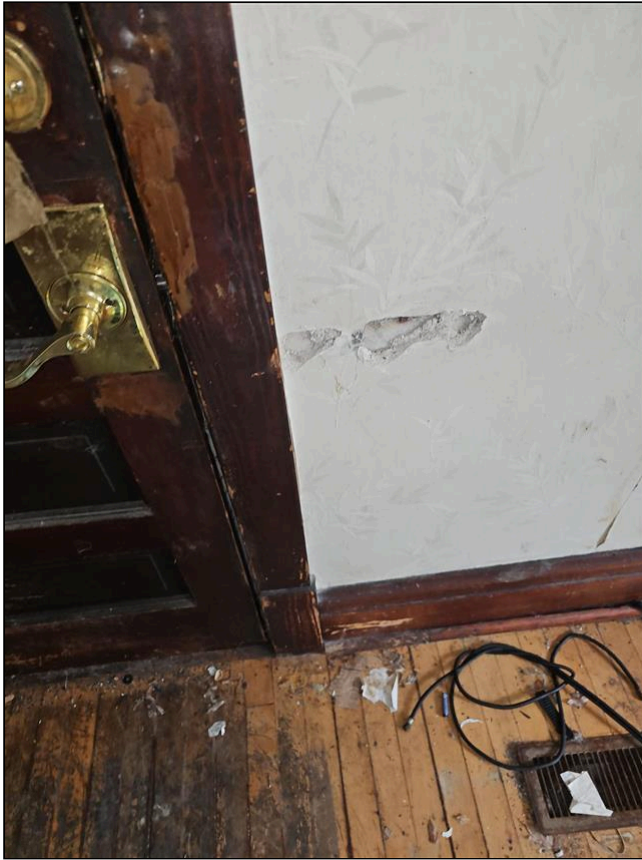
2.1 Item 2(Picture)

🏠 (2) Exterior doors and frames are damaged. A general replacement is needed. Item 2(Picture)

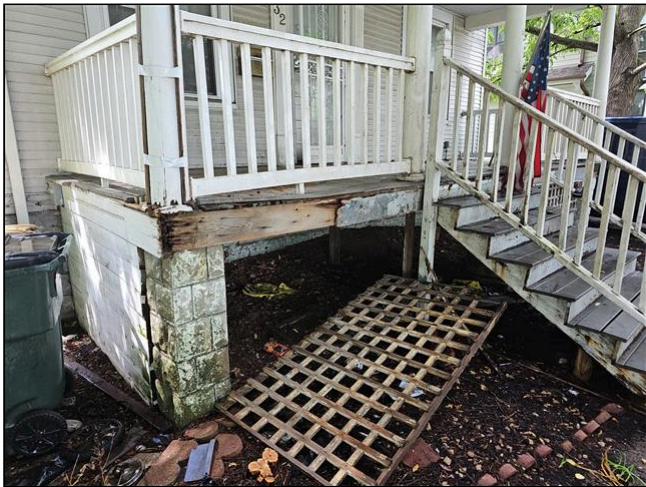
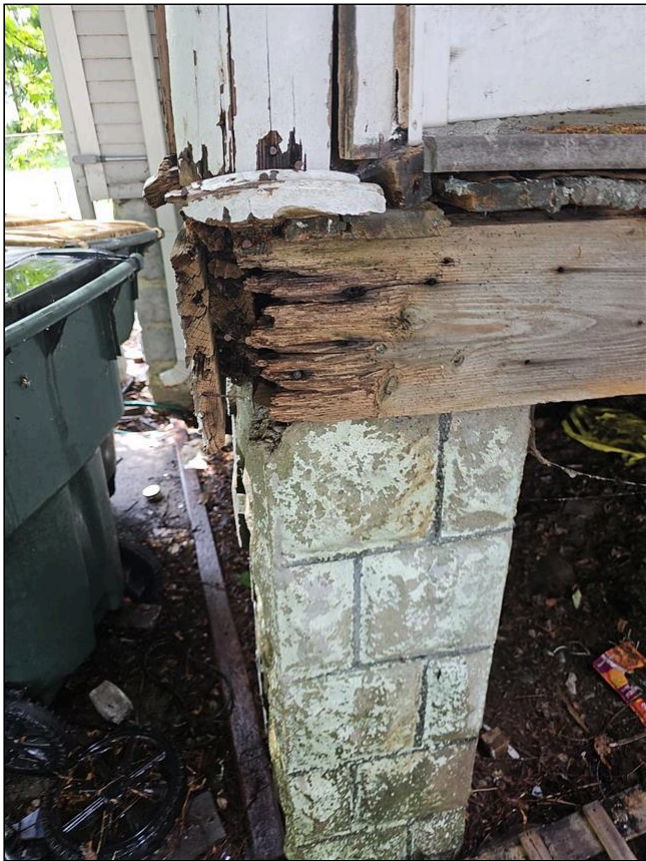
(1) The covered deck at the front of home structure is deteriorated, sagging and unsafe. Concern that deck could collapse if a person walks on it. Stair stringers appear unsafe and not properly supported. A fall or injury may occur if not repaired. A general replacement is likely. Recommend further evaluation by a qualified general contractor and repair or replace as needed. Repair / replacement costs will be significant. Item 1(Picture) Item 2(Picture) Item 3(Picture) Item 4(Picture) Item 5(Picture) Item 6(Picture)

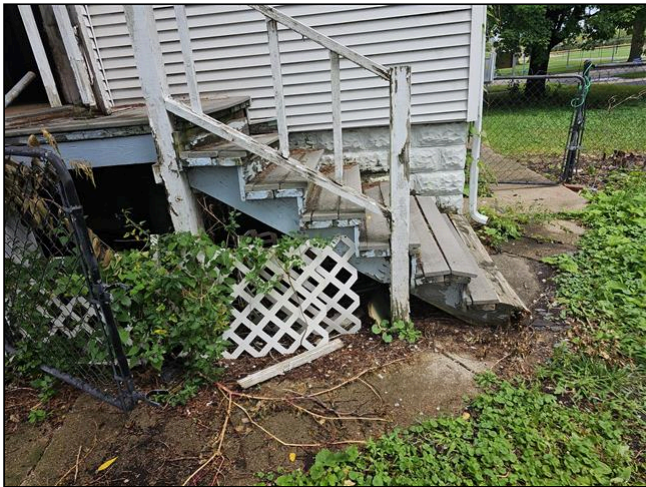
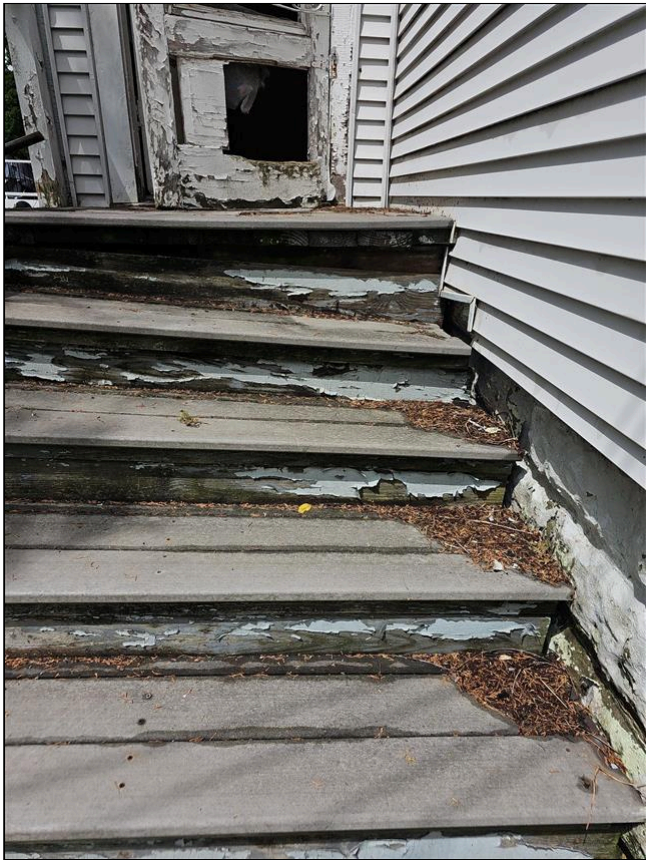
(2) The rear stairway is deteriorated and collapsing. A general replacement is needed

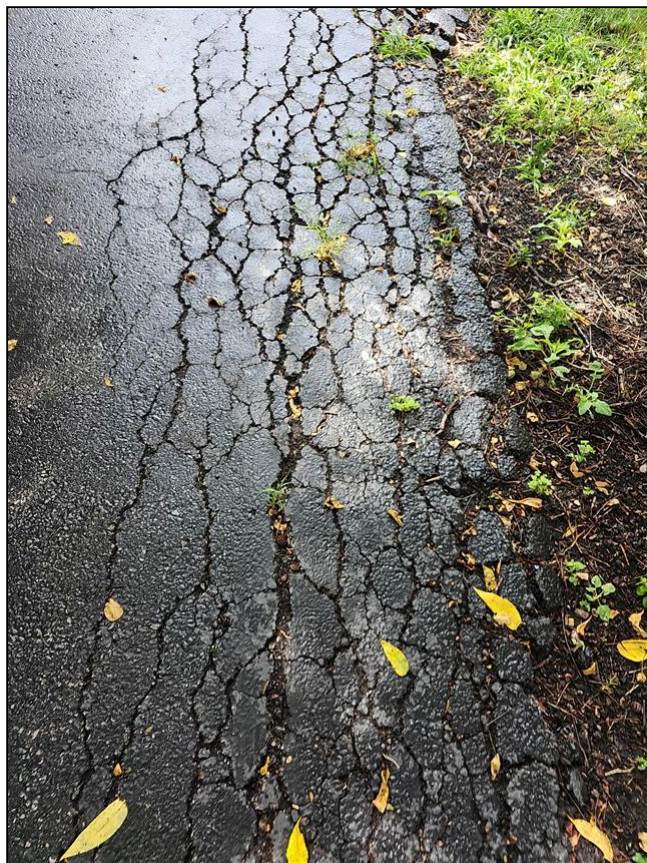
2.3 Item 1(Picture)

(1) The asphalt driveway shows significant alligatoring, cracks and settlement and appears to have exceeded it's life expectancy. A general replacement is needed. A qualified asphalt contractor should perform the work. Item 1(Picture)

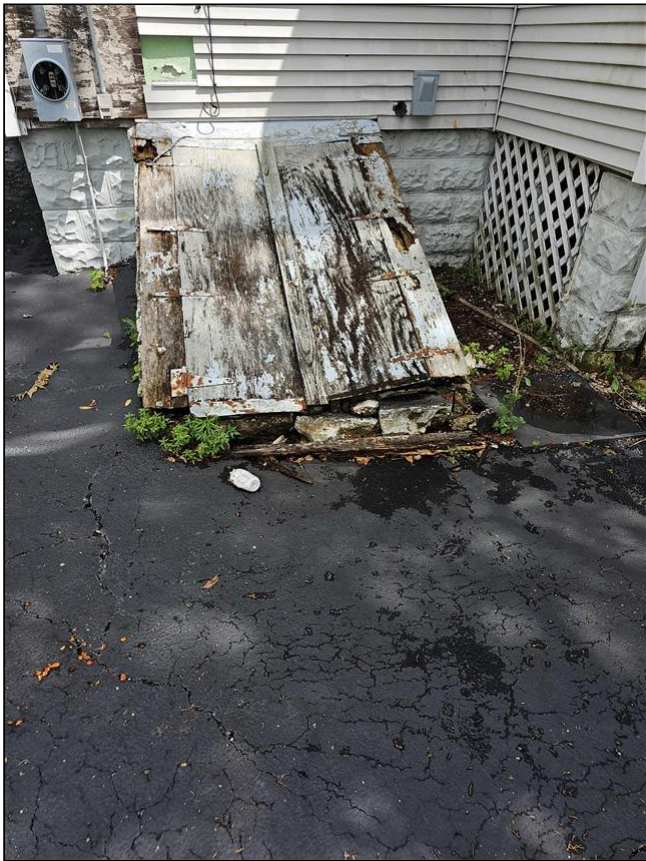
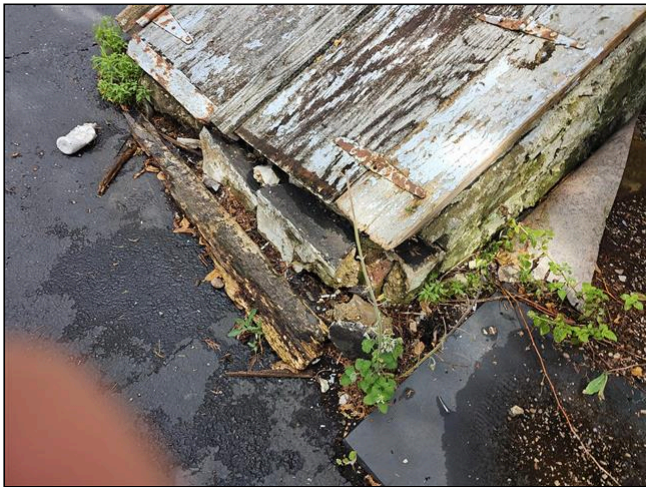
(2) The retaining wall for the rear basement entry is deteriorated and beginning to fail. This is considered unsafe. A general replacement is needed. Recommend further evaluation by a qualified contractor and repair or replace as needed. Repair / replacement costs will be significant. Item 2(Picture)  
Item 3(Picture)

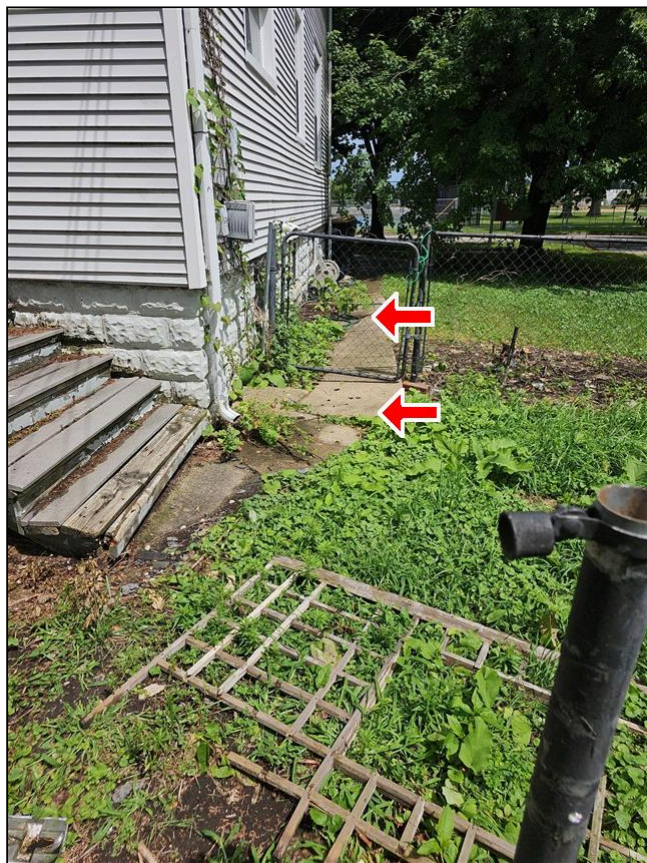
2.3 Item 4(Picture)

- 🏠 (3) The concrete walkway at the left side of home (facing front) has dropped or settled and sloped towards the structure. This can cause or contribute to moisture intrusion into the home. Recommend further evaluation by a qualified contractor and repair or replace as needed. Item 4(Picture)

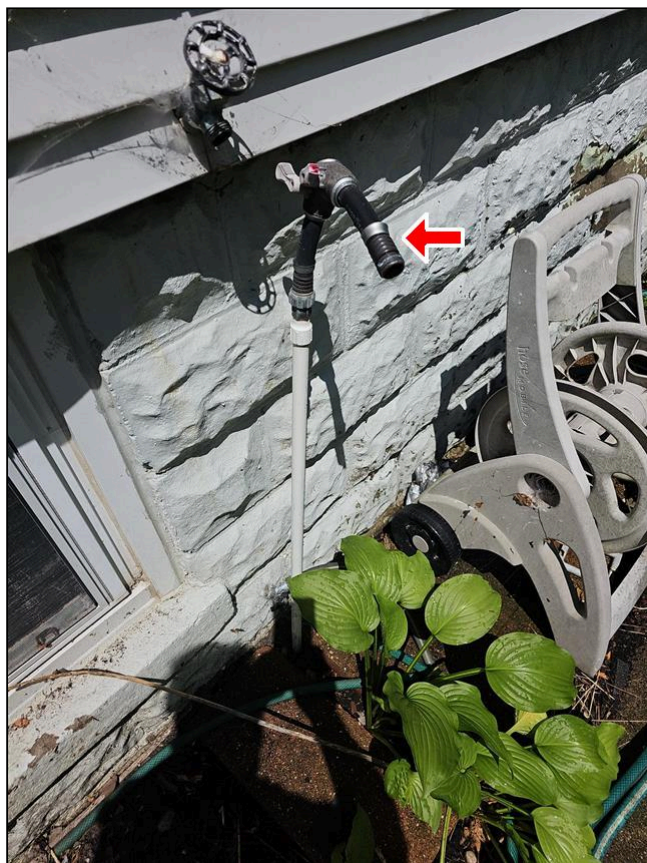
2.5 Item 1(Picture)

Improper and unsafe hose bib connections at exterior. Recommend further evaluation by a qualified plumbing, contractor and repair or replace as needed. Item 1(Picture)

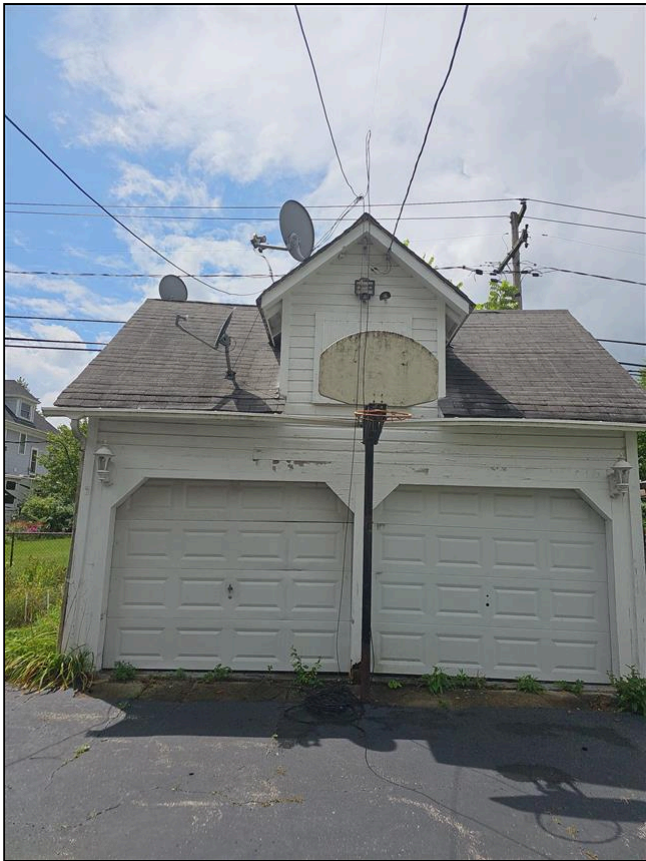
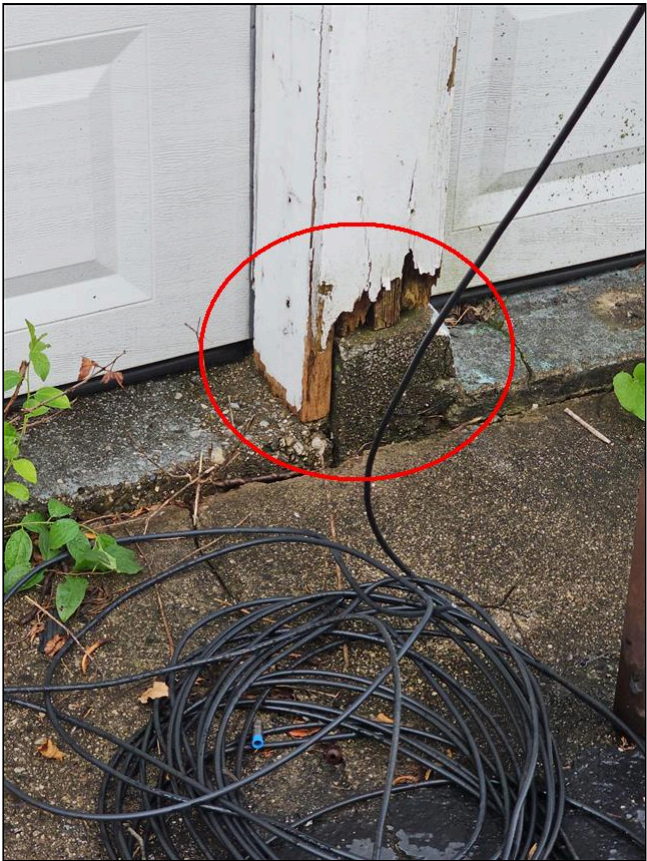
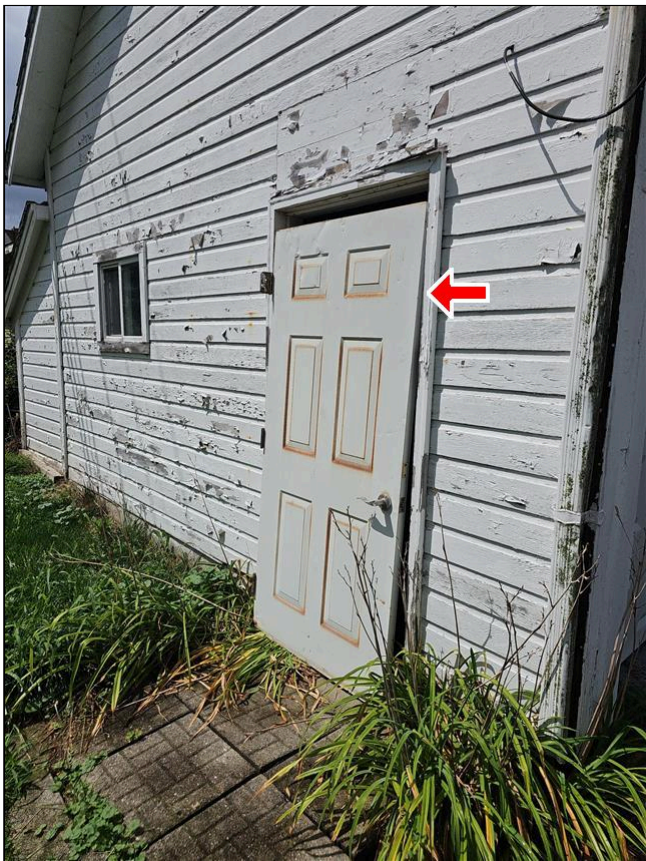
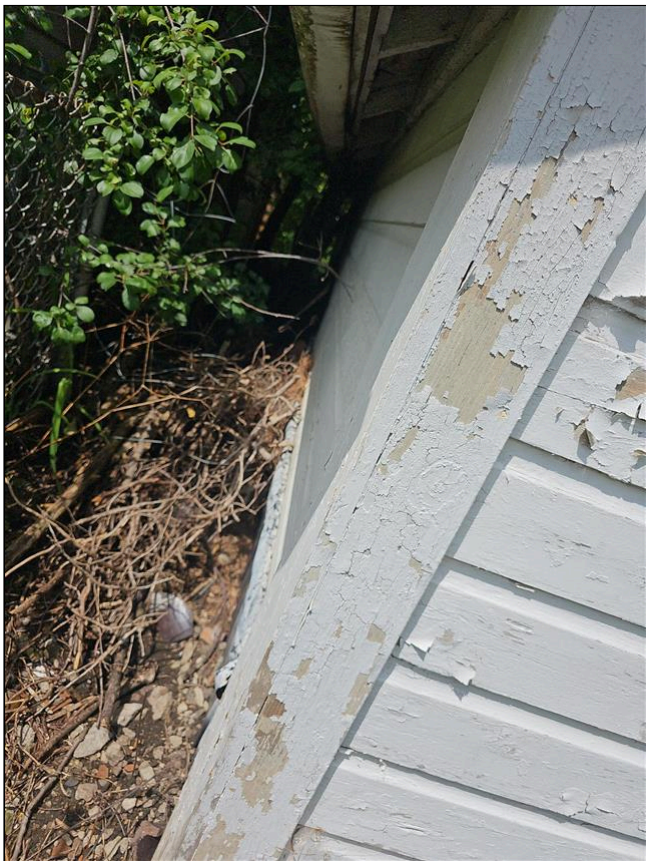
There are too many issues to list with the garage, including 3 layers of asphalt roof shingles are present and are improperly installed over old wood cedar singles. The maximum allowed is two layers. This causes a lot of weight that can cause the structure to fail. Deteriorated wall, framing and columns. The entry door and frame are damaged and no longer functional. Door is loose and leaning against door frame. Animal and/or rodent signs / damage including droppings inside of garage. Trees in contact with structure should be removed. Recommend further evaluation by a qualified general contractor and repair or replace as needed. Repair / replacement costs will be significant Item 1(Picture) Item 2(Picture) Item 3(Picture) Item 4(Picture) Item 5(Picture) Item 6(Picture) Item 7(Picture) Item 8(Picture) Item 9(Picture) Item 11(Picture) Item 12(Picture) Item 13(Picture)

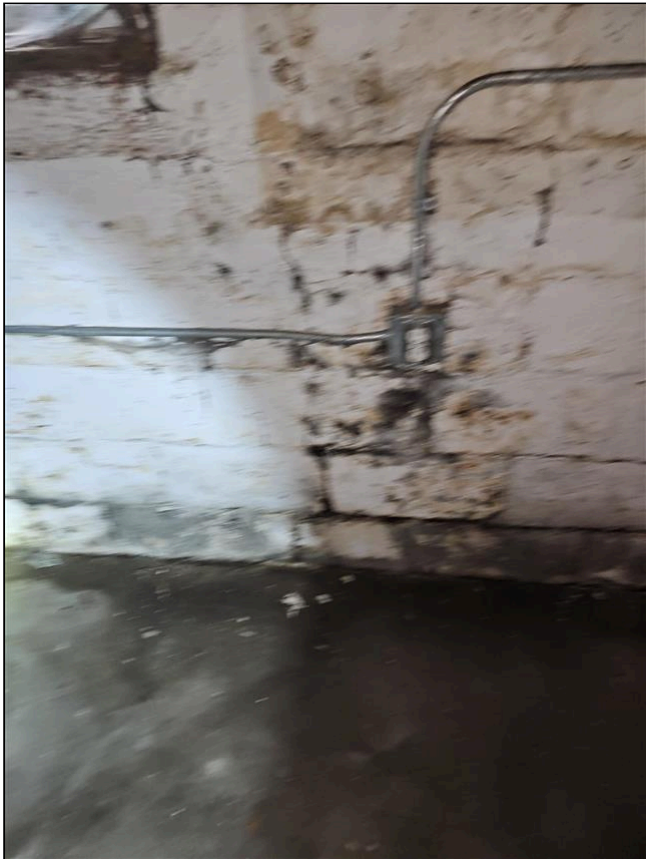
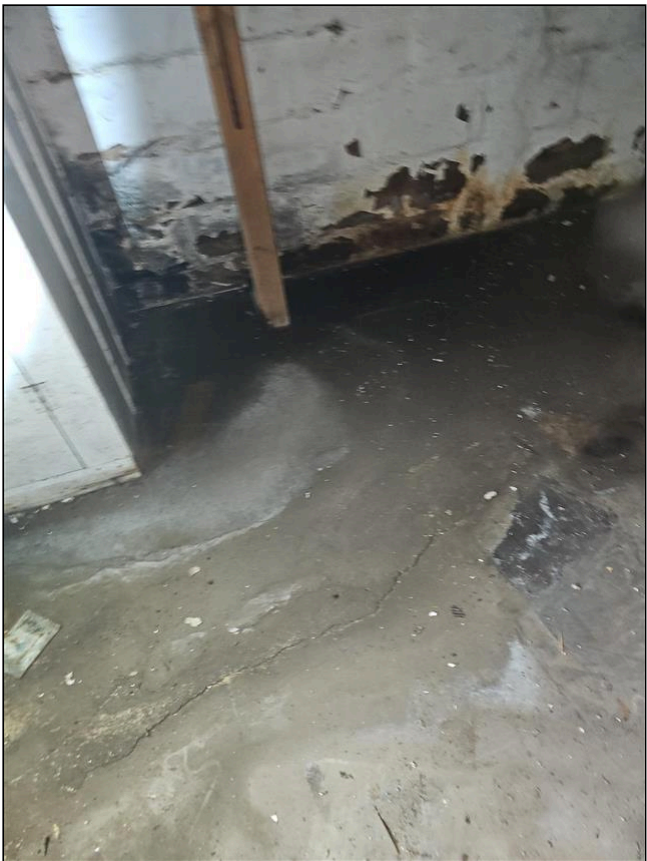
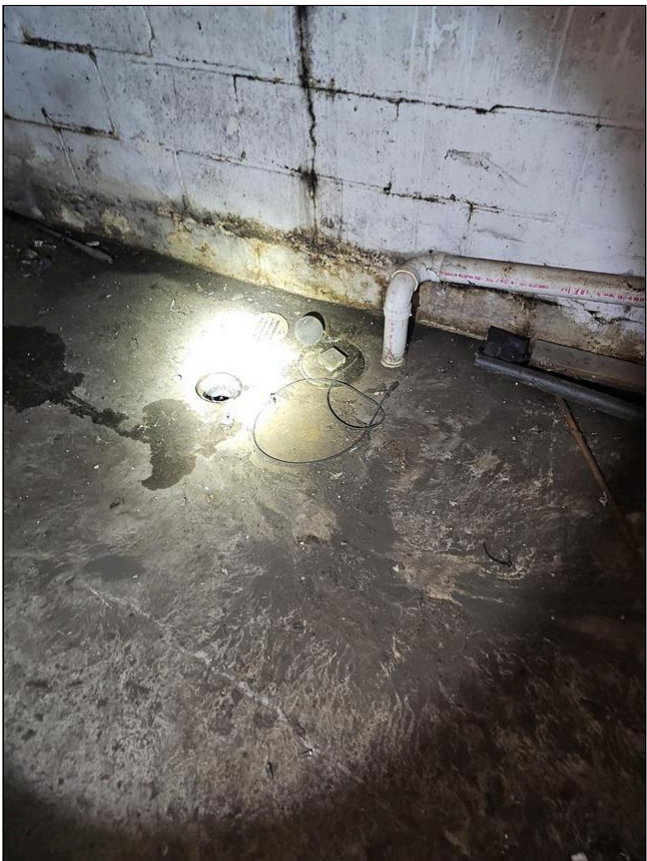
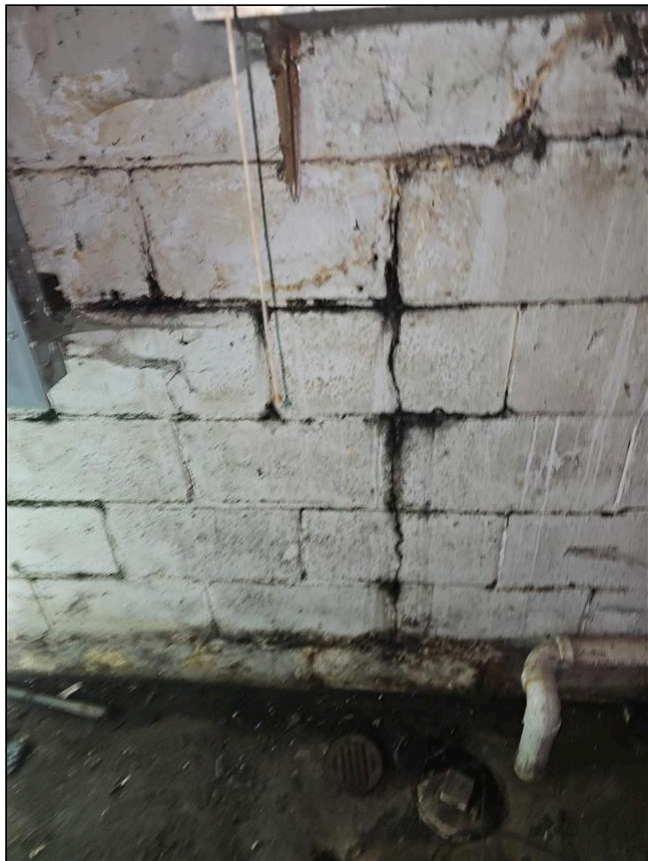
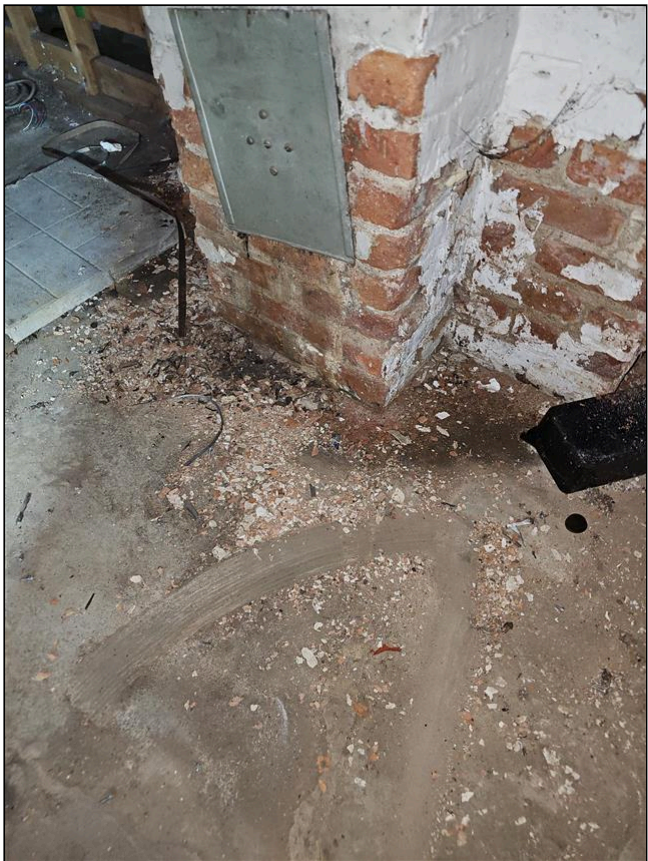
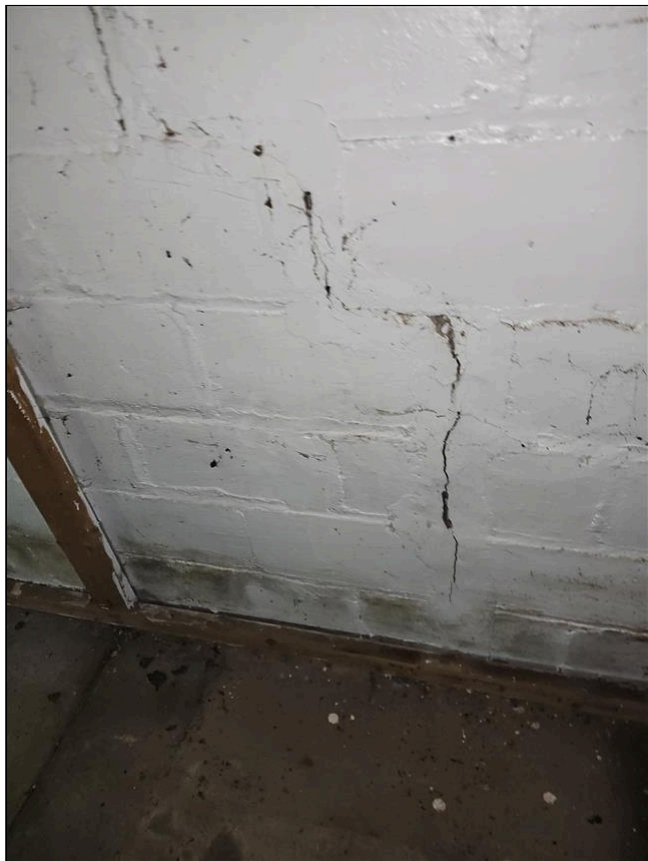
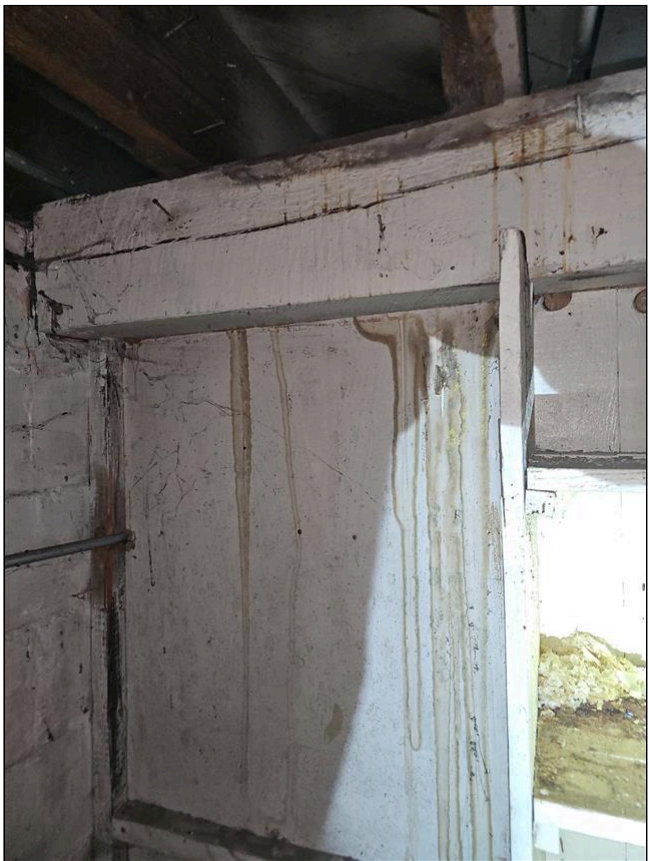
The masonry block foundation wall shows significant water intrusion into the basement. Significant cracking and shifting is occurring. These types of foundation walls are very porous and prone to water intrusion and shifting and are typically no longer allowed by your local municipality for new construction. Recommend further evaluation by a qualified structural engineer and repair or replace as needed. Repair / replacement costs will be significant. Item 1(Picture) Item 2(Picture) Item 3(Picture) Item 4(Picture) Item 5(Picture) Item 6(Picture) Item 7(Picture) Item 8(Picture) Item 9(Picture) Item 10(Picture)

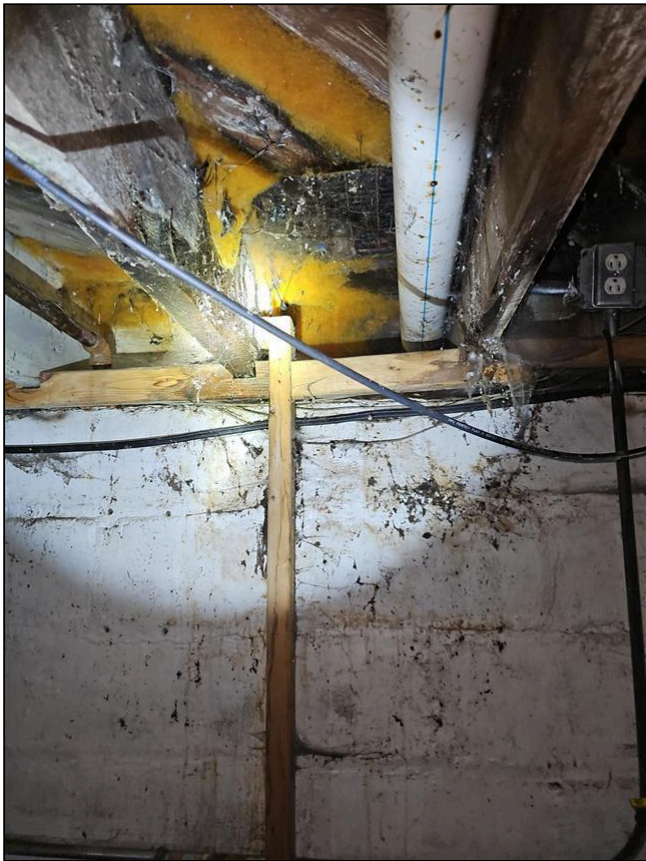
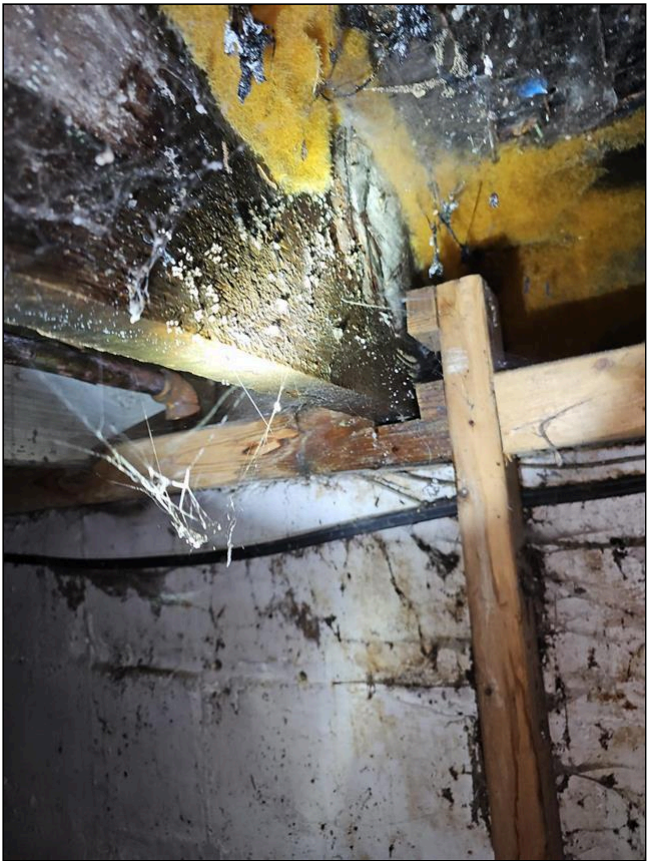
The wood floor joists, floor sheathing and sill plate shows deterioration from moisture intrusion in areas. Recommend further evaluation by a qualified structural engineer and repair or replace as needed. Repair / replacement costs will be significant.

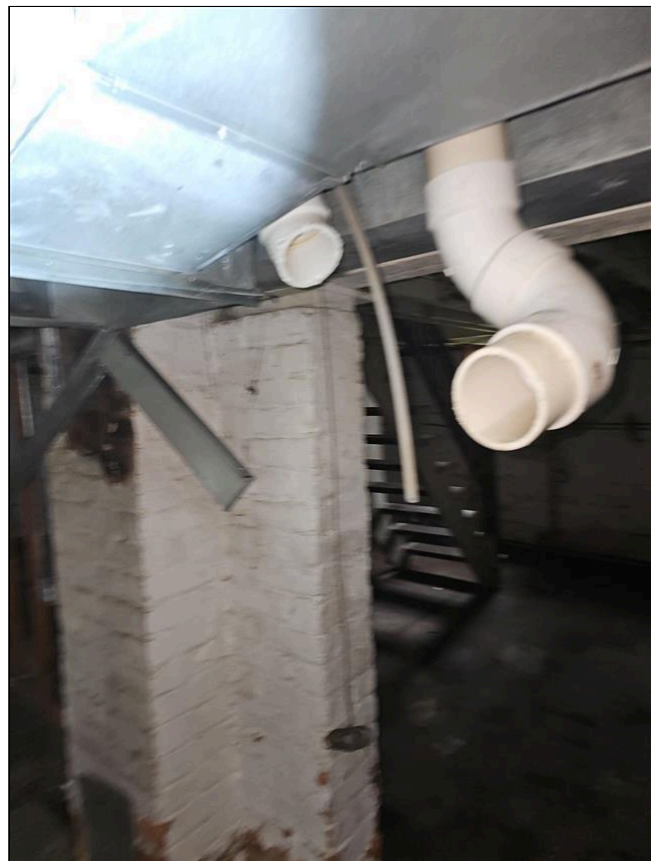
6.1 Item 1(Picture)

The plumbing waste and water lines are damaged and missing in areas. Recommend further evaluation by a qualified plumbing contractor and repair or replace as needed.

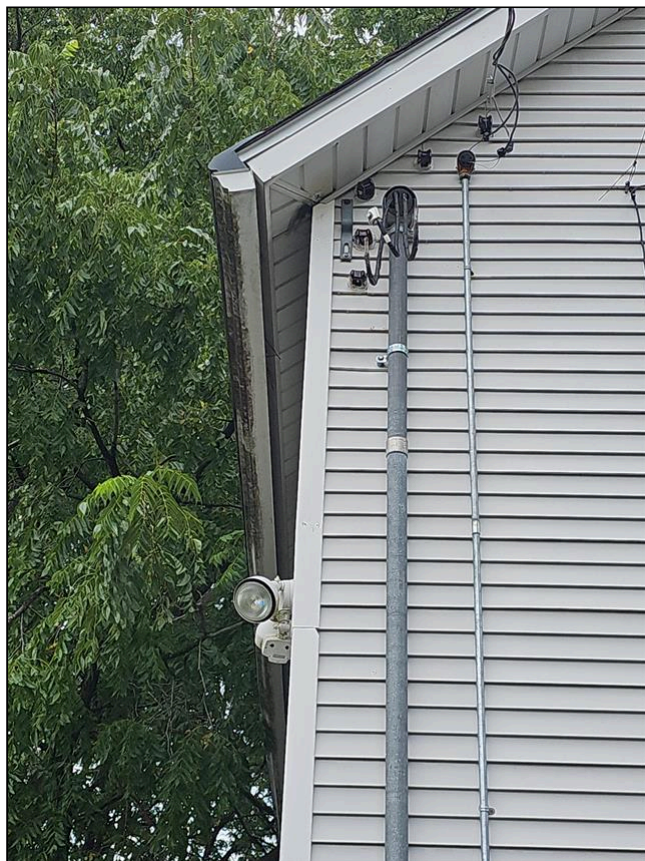
7.0 Item 1(Picture)

The service conductors for the electrical service to the home have been removed. The electrical service to the garage has exposed wiring and is not proper or safe. Electrical issues are considered unsafe until repaired. Recommend further evaluation of the electrical system by a qualified electrical contractor and correct as needed. Repair / replacements costs will be significant. Item 1(Picture)

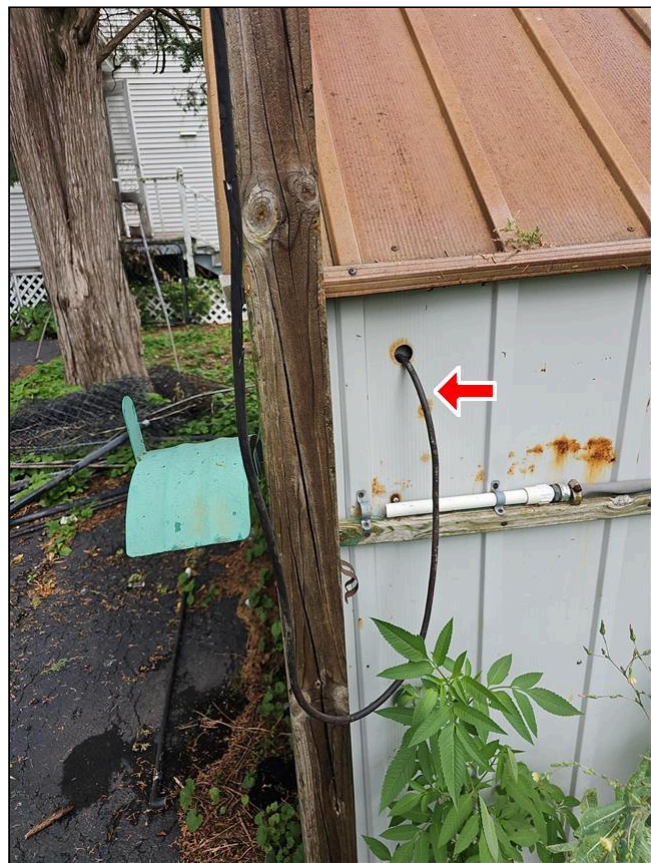
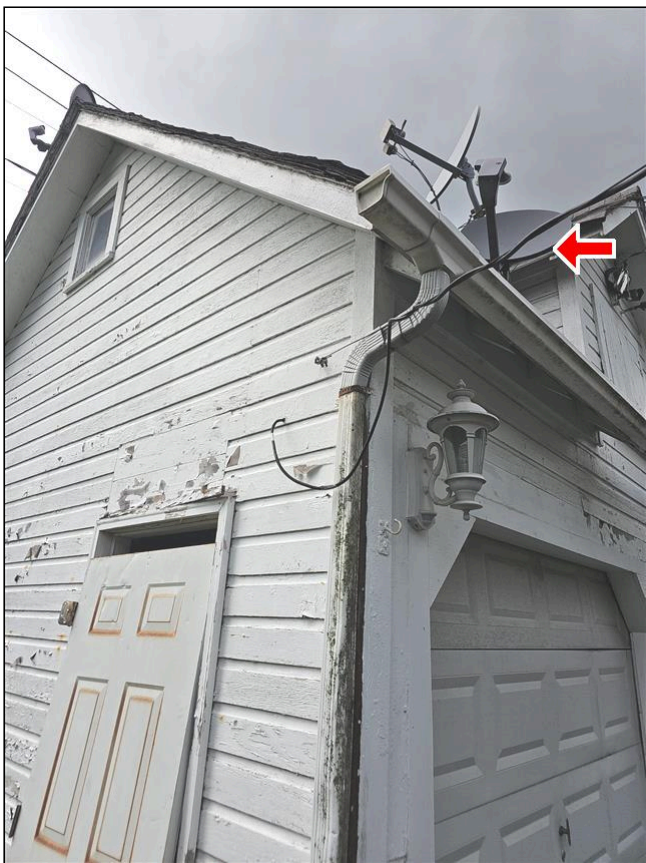
Electrical issues such as: Unsafe and dangerous electrical connections to garage and shed. Open and damaged electrical in many areas throughout the home and exterior (to numerous to list). Electrical

issues are considered unsafe until repaired. Recommend further evaluation of the electrical system by a qualified electrical contractor and correct as needed. Repair / replacements costs will be significant. Item 1(Picture) Item 2(Picture) Item 3(Picture) Item 4(Picture) Item 5(Picture)
