AGENDA  
DESIGN COMMISSION  
Community Room, 3rd Floor  
Arlington Heights Village Hall, 33 S. Arlington Heights Rd.  
Arlington Heights, IL 60005  
September 10, 2024  
6:30 PM

A. DC#24-049(H) - 32 N. Belmont Ave - SF/Teardown

It is recommended that the Design Commission require revisions and re-review the proposed new single-family residence located at 32 N. Belmont Avenue. This recommendation is based on the architectural plans received 10/25/23, material list and samples received 9/29/23, and the following:

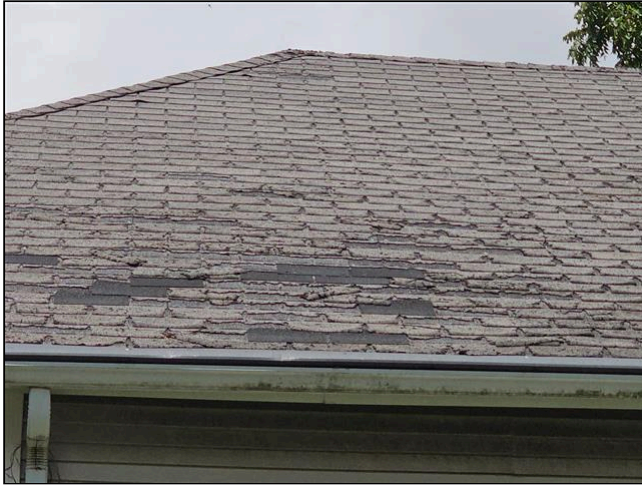
1.0 Item 3(Picture)

Tree limbs have fallen unto the roof and are in contact with the roof. Damage to roofing and structure has occurred. Roof shingles are also deteriorated and missing. Water is entering the structure. Repairs to the roof structure and replacement of the roofing are needed. Recommend further evaluation by a qualified general contractor and roofing, contractor and repair or replace as needed. Repair / replacement costs will be significant. Item 1(Picture) Item 2(Picture) Item 3(Picture)

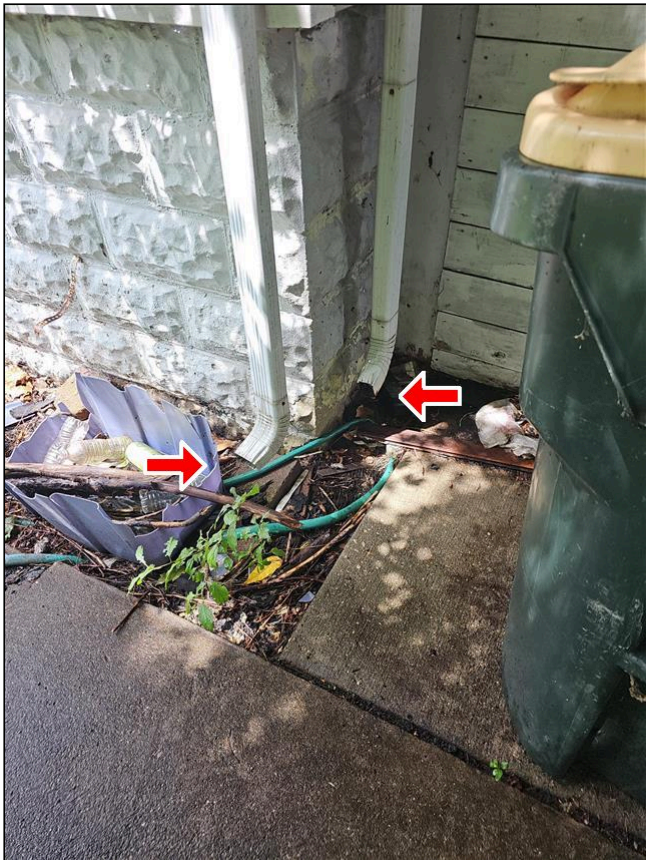
1.2 Item 2(Picture)

- ⚠ The gutters are full of debris and appear damaged and leaking. Downspouts are missing parts and extensions. Because of the amount of damage the wood fascia boards are likely damaged / deteriorated. Recommend further evaluation by a qualified general contractor and repair or replace as needed. Repair

/ replacement costs may be significant. Item 1(Picture) Item 2(Picture) Item 3(Picture)

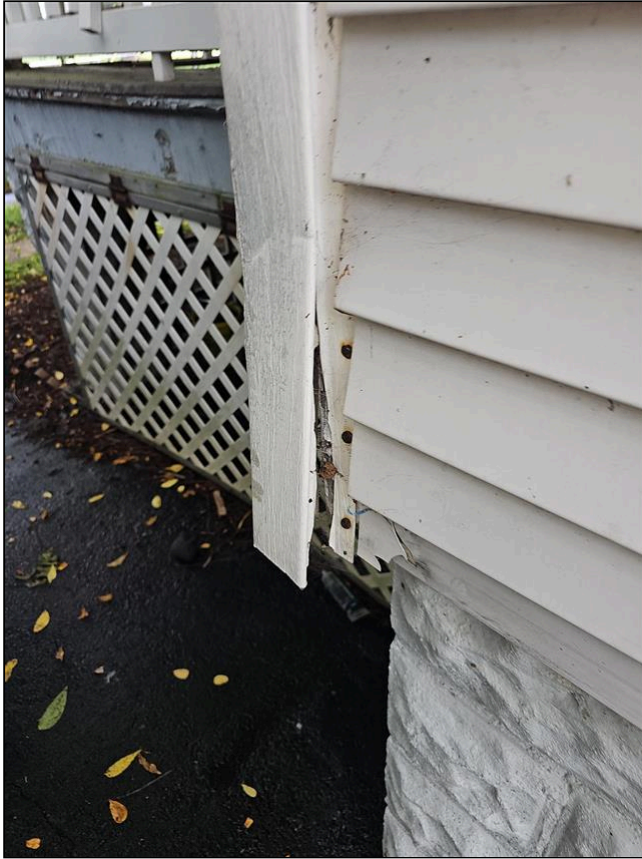
2.0 Item 3(Picture)

The vinyl siding and accessories at the exterior of home is damaged and missing in areas and appears to be improperly installed directly over /onto the old wood siding. Recommend further evaluation by a qualified general contractor and repair or replace as needed. Repair / replacement costs may be significant. Item 1(Picture) Item 2(Picture) Item 3(Picture)

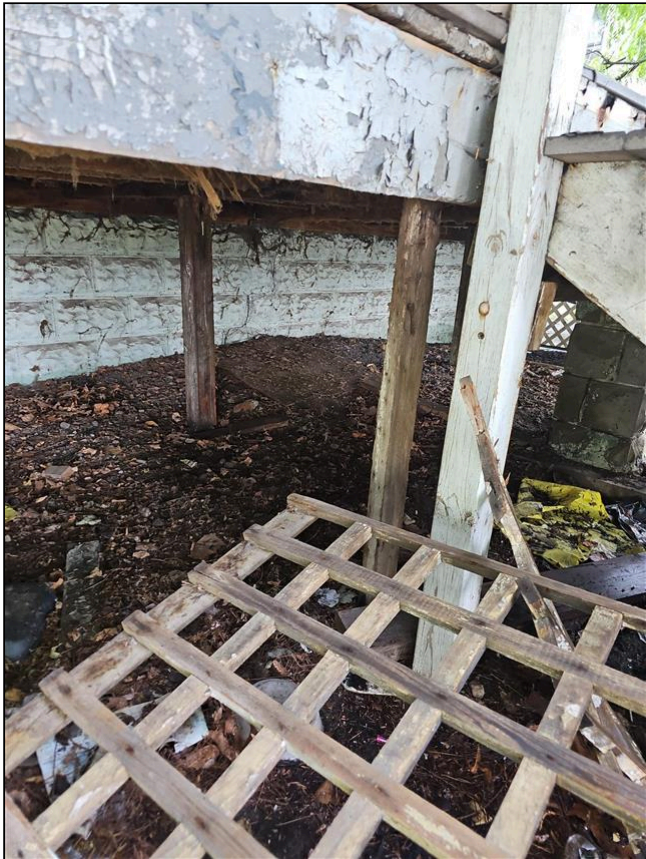
2.2 Item 3(Picture)

(1) The covered deck at the front of home structure is deteriorated, sagging and unsafe. Concern that deck could collapse if a person walks on it. Stair stringers appear unsafe and not properly supported. A fall or injury may occur if not repaired. A general replacement is likely. Recommend further evaluation by a qualified general contractor and repair or replace as needed. Repair / replacement costs will be significant. Item 1(Picture) Item 2(Picture) Item 3(Picture) Item 4(Picture) Item 5(Picture) Item 6(Picture)
